Fire resistance test report

Test standard: BS EN 1365-1:2012 Corr 2013

Product: Asymmetric loadbearing wall comprised of a timber stud OSB panel coated with 'FRED'

Report number: WF538940

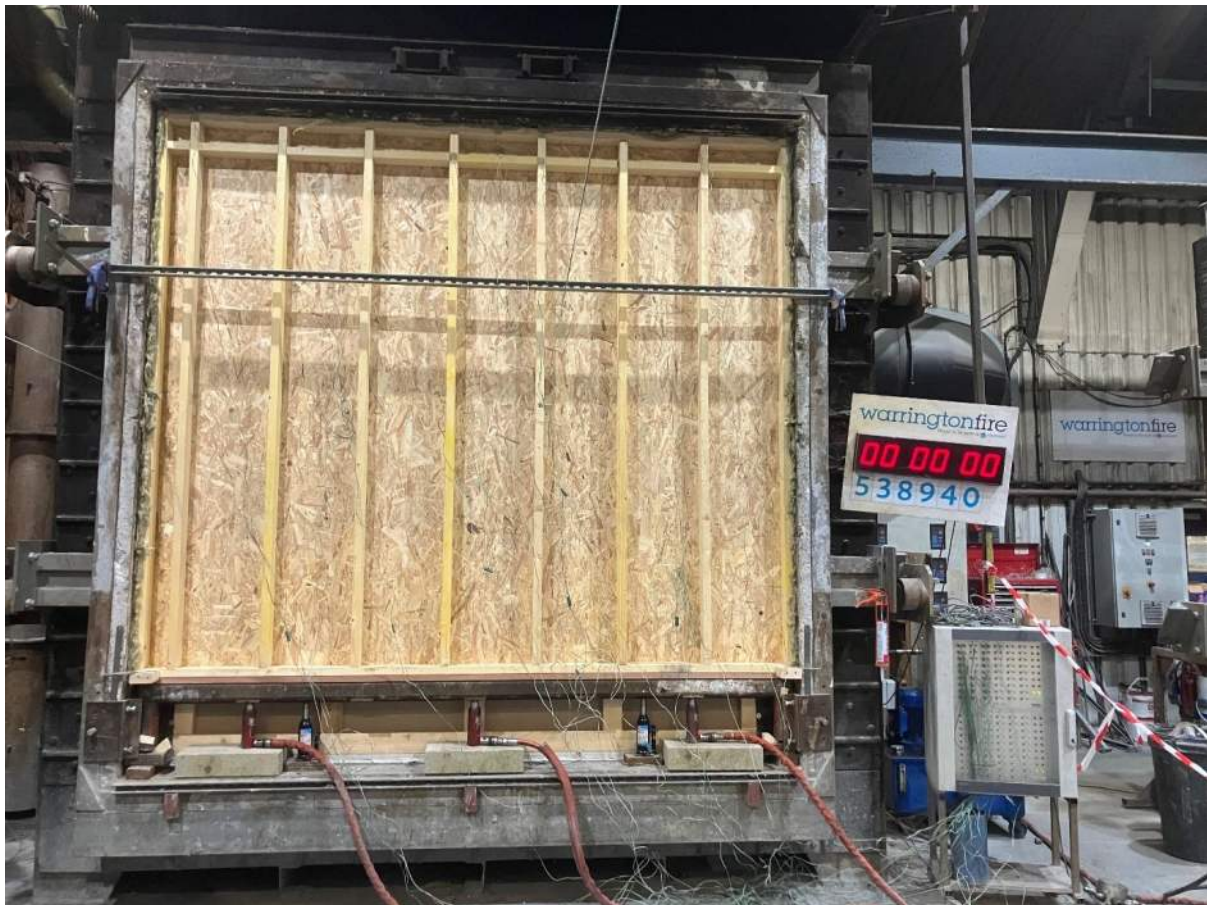
Figure 1 Unexposed face photograph of test construction

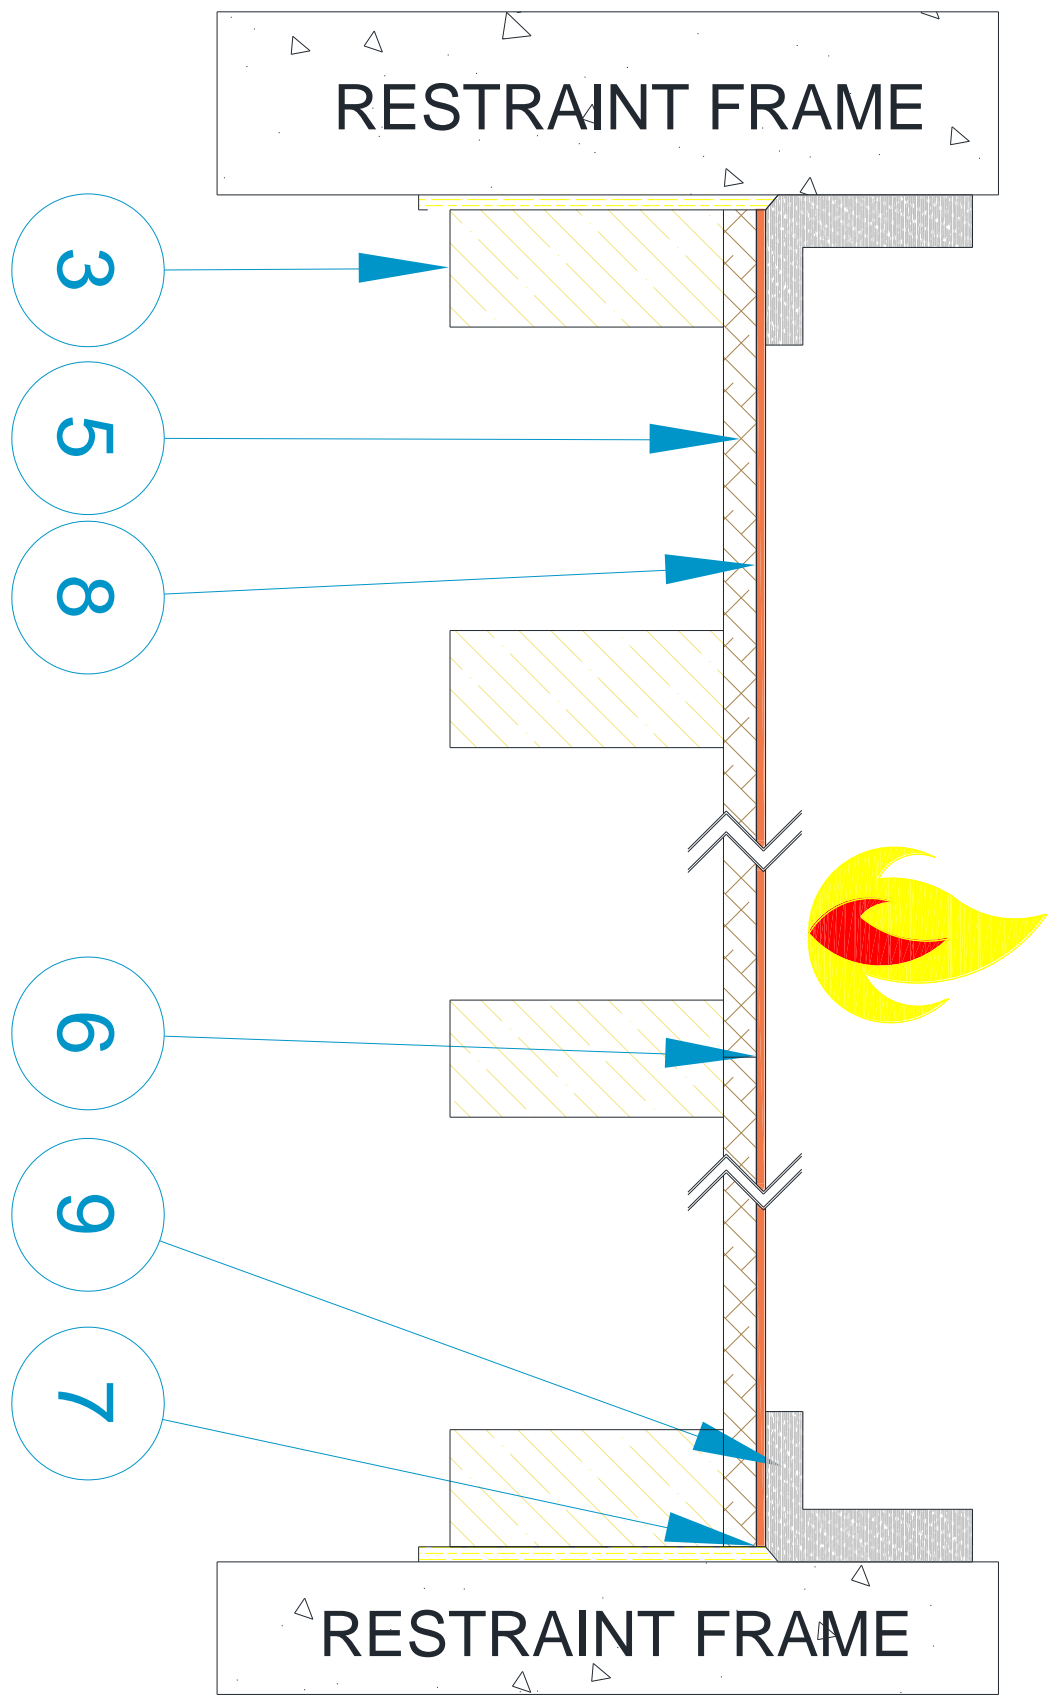
Figure 3 Cross section A – A
Do not scale.

The leaders in the drawings (Figures 2 - 4) represent the items listed in Section 3.3. All measurements are in millimetres – unless indicated otherwise.

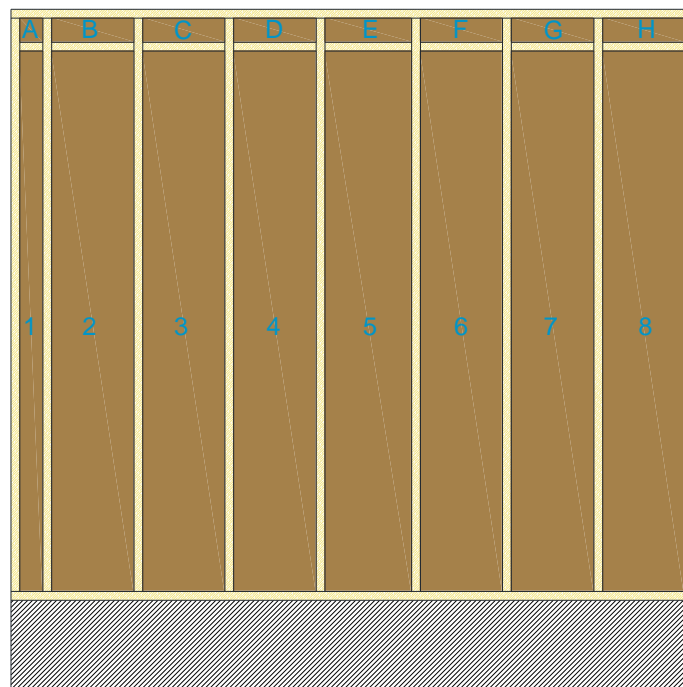
Figure 6 shows a diagram of the panels as referenced in Table 7

Figure 6 Panel Arrangement for observations

Min	Sec	Observation
00	00	Commencement of test.
05	30	There is smoke issuing at the top of panels 2,3,4,5,7,8
06	55	There is smoke issuing at the lower end of 2,3,4,7,8
11	38	There is an increase in smoke issuing at all previous points
15	01	There is smoke issuing at the stud between panels 2 and 3, approximately 80 mm from the base on the right-hand side and approximately 500 mm from the base on the left-hand side
18	08	There is discolouration at the smoke issuing points between panels 2 and 3
18	38	There is an increase in smoke issuing at all points
19	36	There is discolouration at the top right corner of panel 4
20	13	There is discolouration at the top right corner of panel 6
20	45	There is discolouration at the top left corner of panel 5
23	50	There is a glow visible at the top right corner of panel 6
24	51	There is a glow visible at the top right corner of panel 4
25	26	There is continuous flaming at the left-hand side of the stud between panels 2 and 3, thereby constituting integrity failure

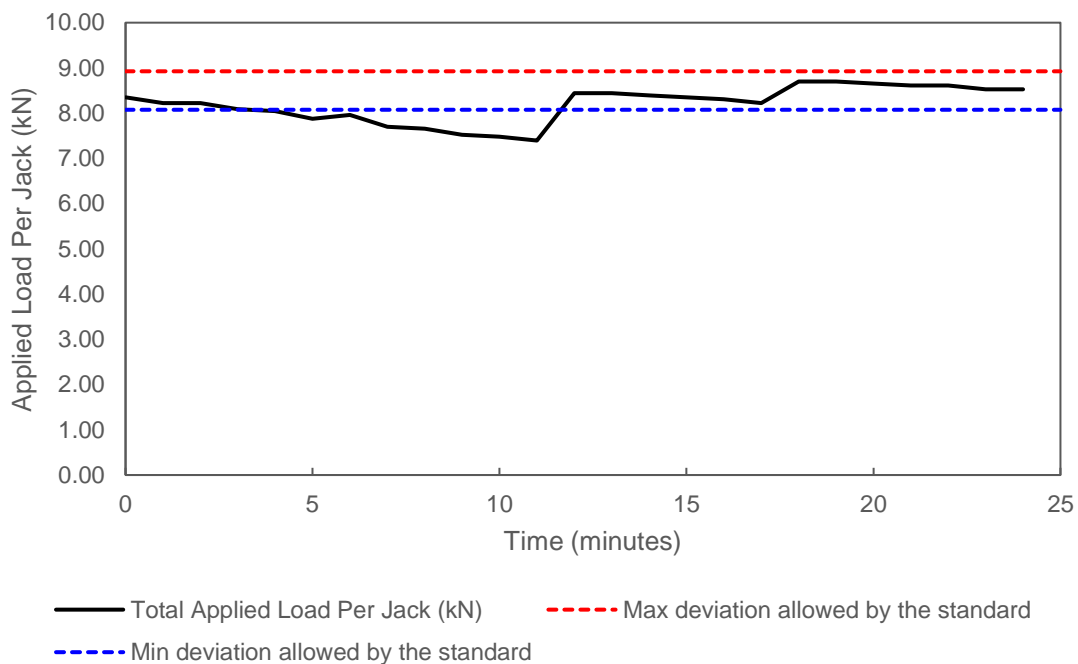
Figure 12 Graph showing the total load applied per loading jack with the associated tolerances as specified in BS EN 1363-1:2020

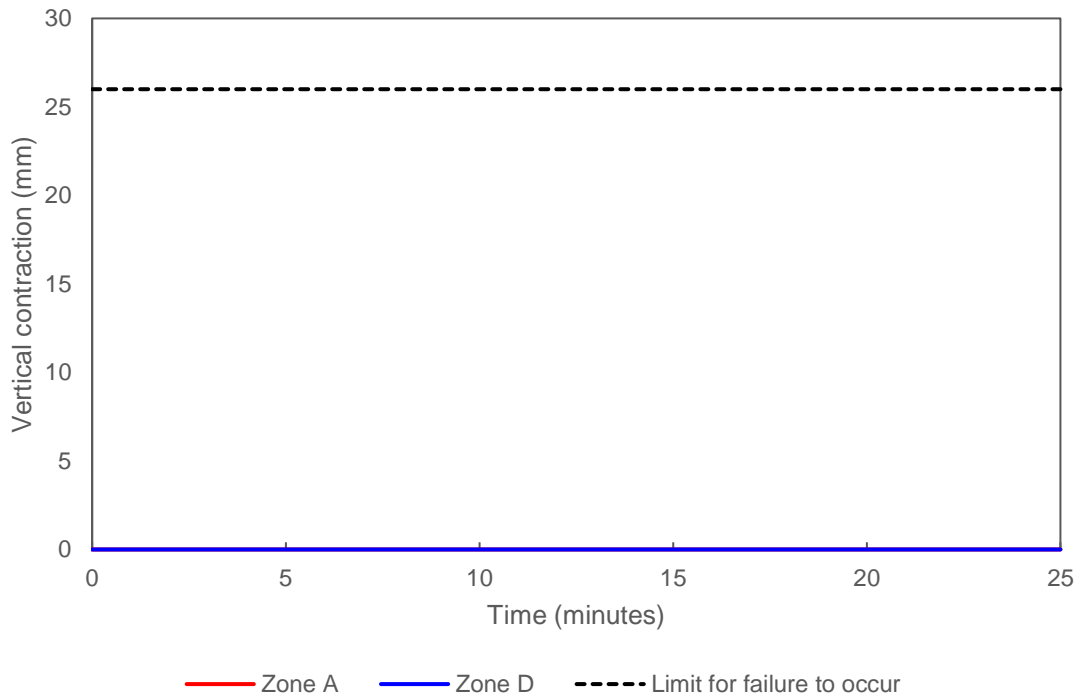
Figure 13 Graph showing vertical contraction of the specimen at Zones A and D and the limit for failure to have occurred

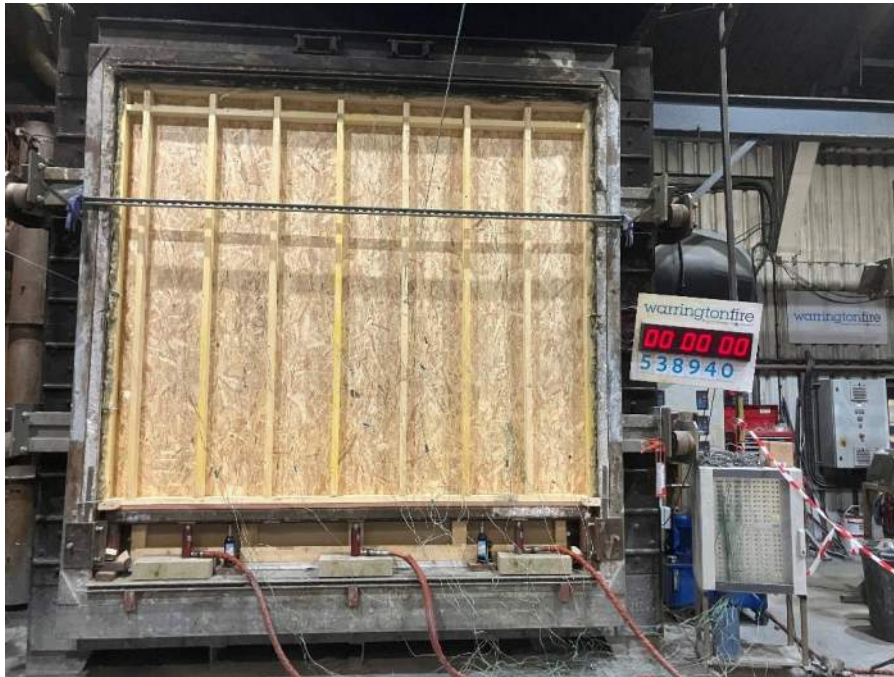
Figure 17 Unexposed face of the specimen before the start of the test

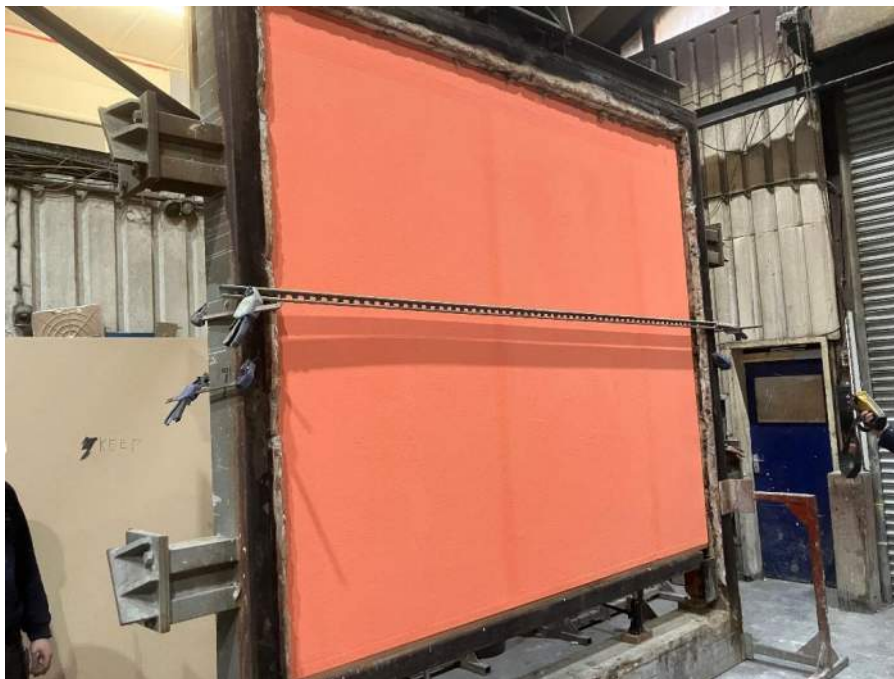
Figure 18 Exposed face of the specimen before the start of the test
(support bar and clamp removed prior to fitting onto furnace as well as the addition of fire stopping around the vertical edges and head)

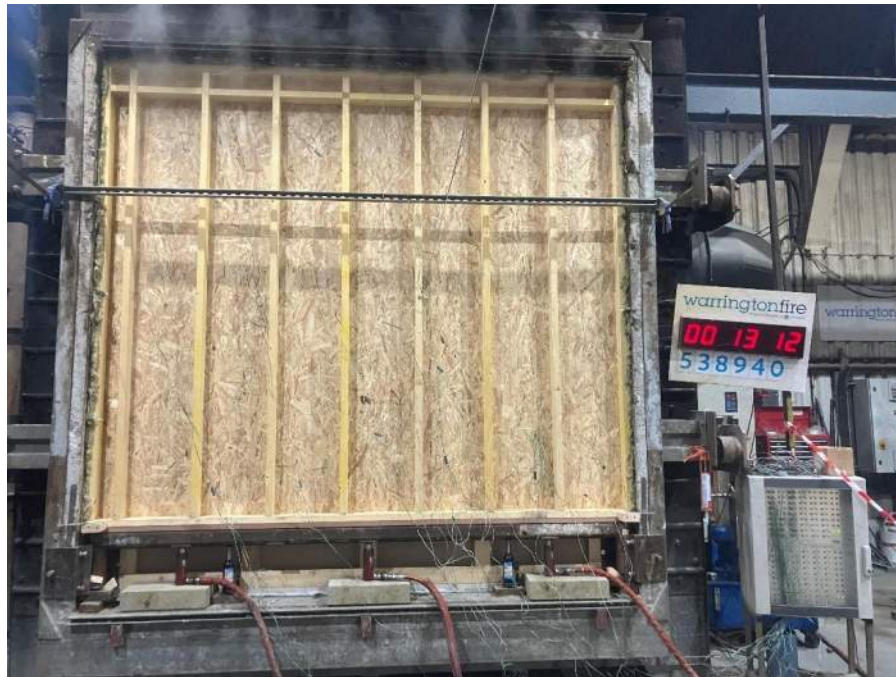
Figure 19 Unexposed face of the specimen after 13:12 minutes of testing

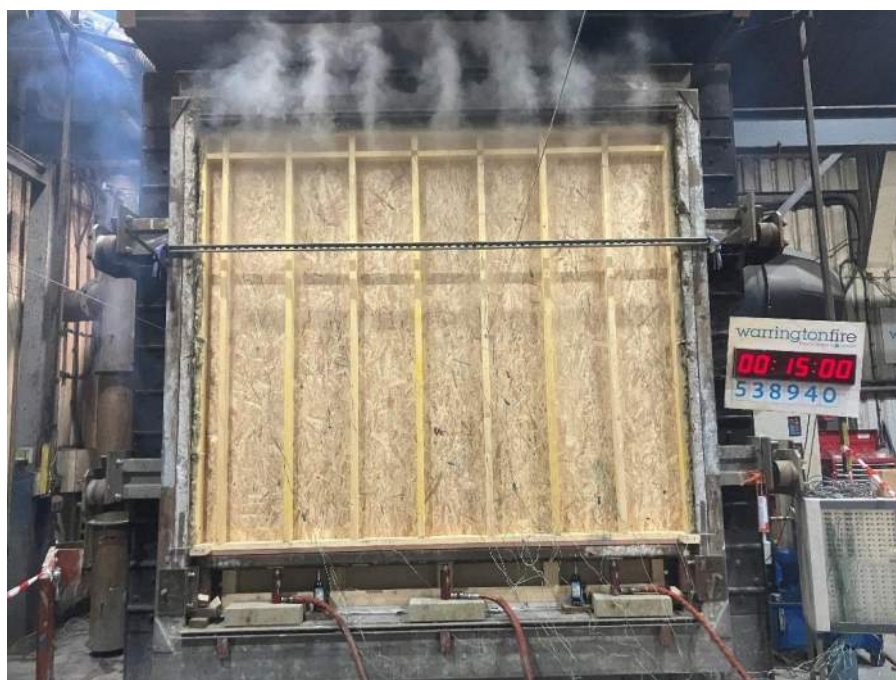
Figure 20 Unexposed face of the specimen after 15:00 minutes of testing

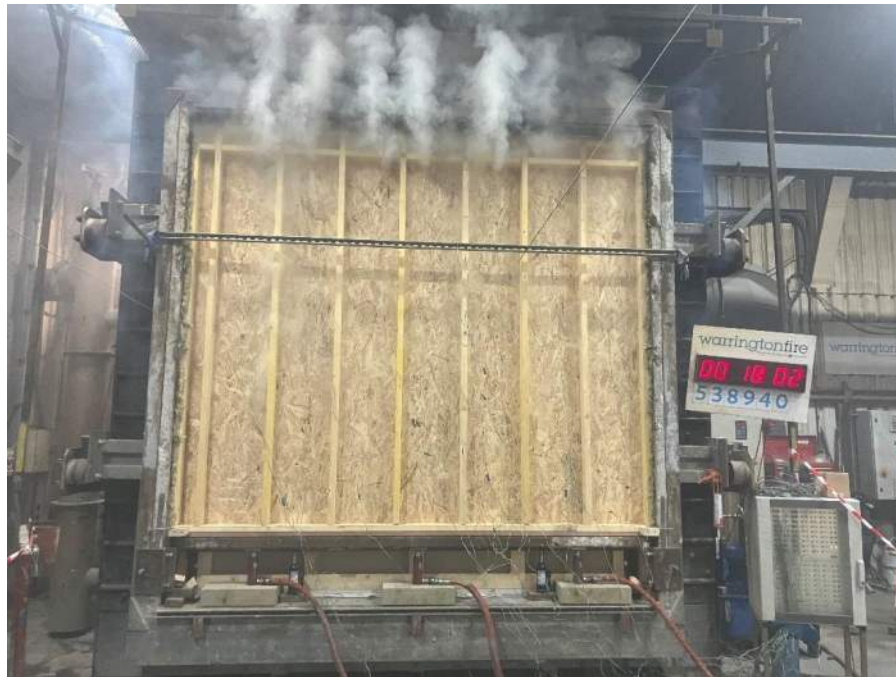
Figure 21 Unexposed face of the specimen after 18:02 minutes of testing

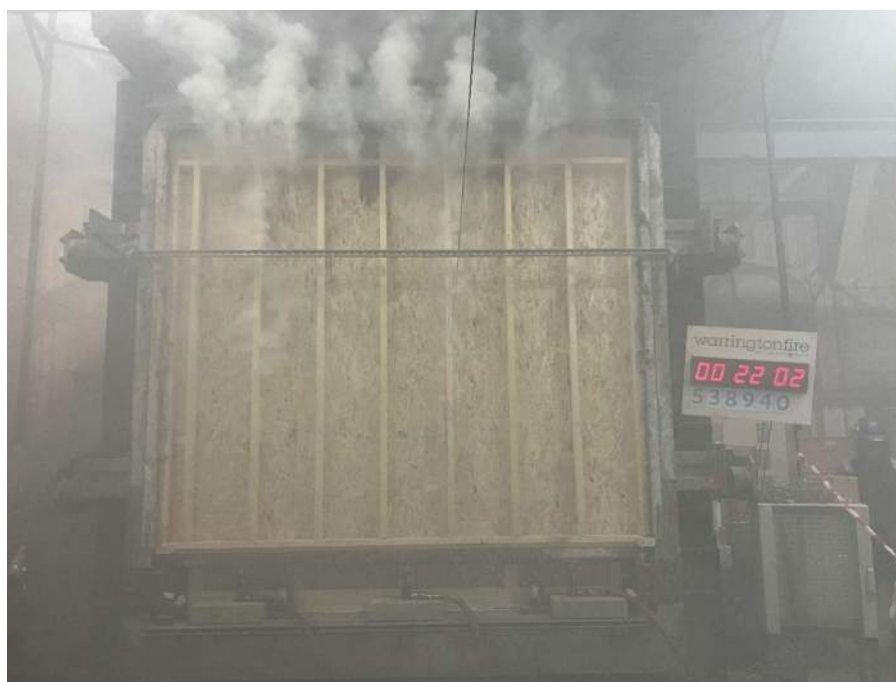
Figure 22 Unexposed face of the specimen after 22:02 minutes of testing

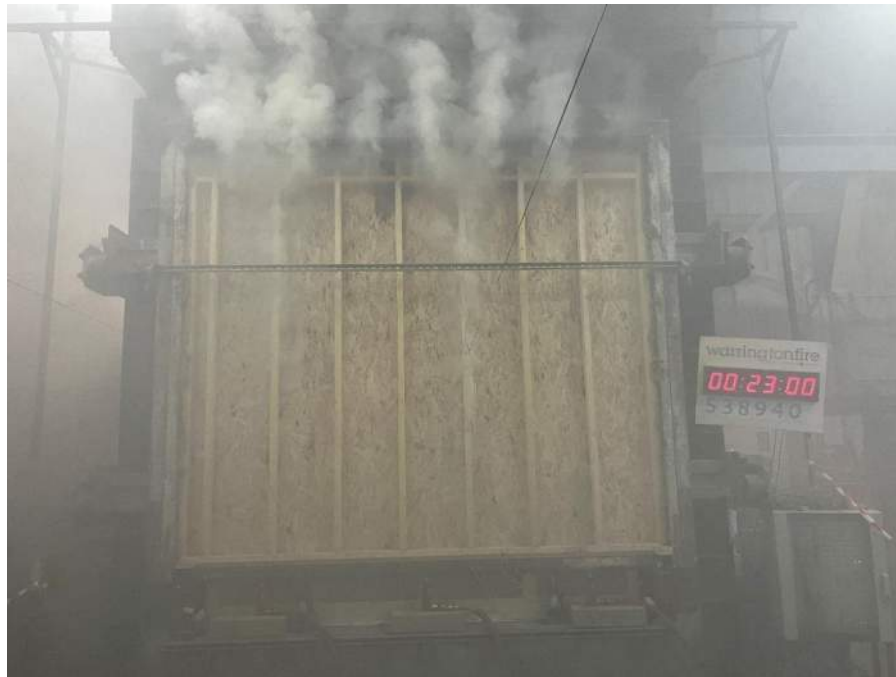
Figure 23 Unexposed face of the specimen after 23:00 minutes of testing

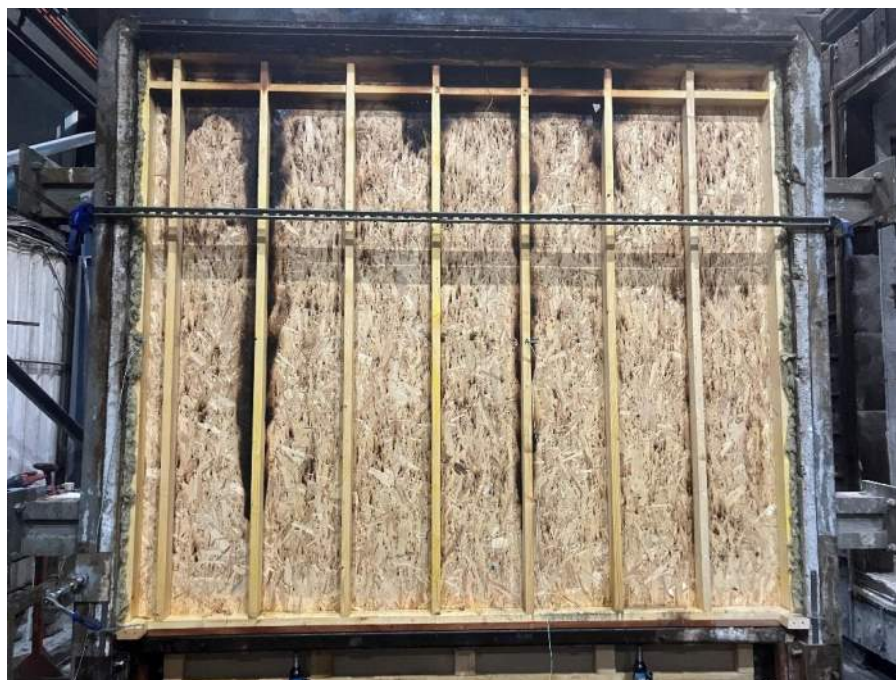
Figure 24 Unexposed face of the specimen after the test

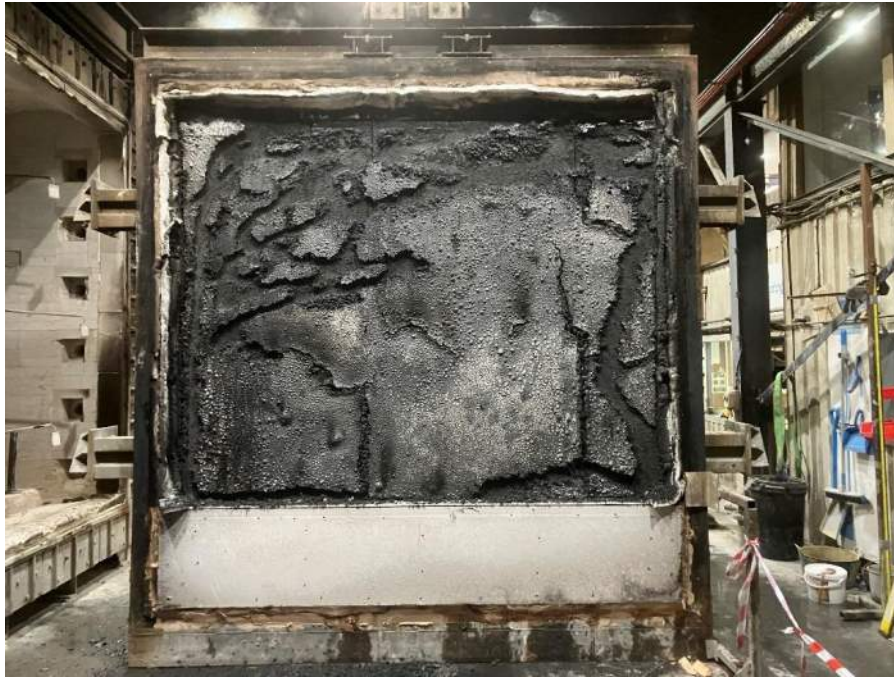
Figure 25 Exposed face of the specimen after the test

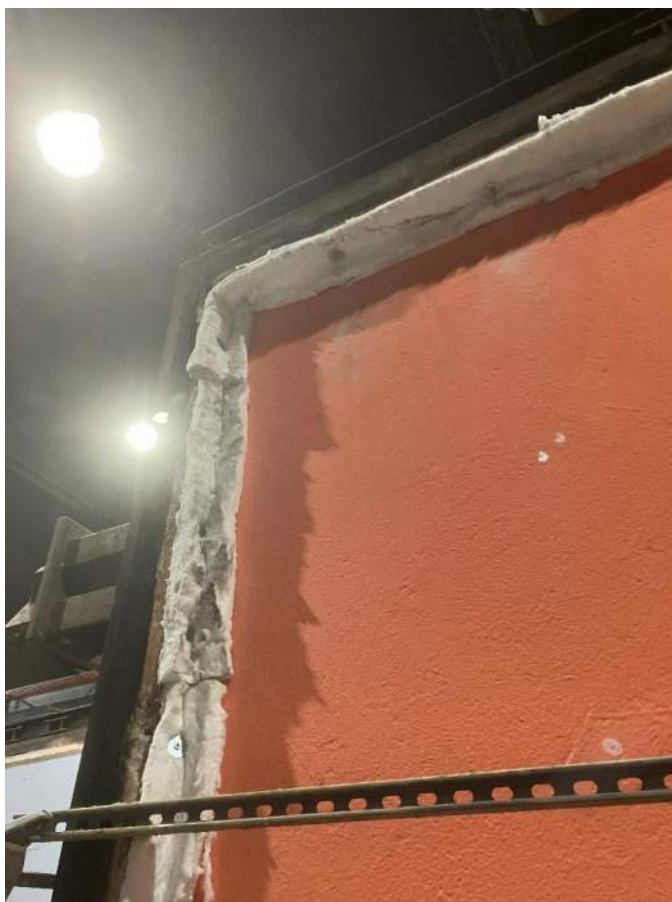
Figure 26 Photo showing fire stopping added to the perimeter of the specimen before the start of the test

9. Fire Stopping		Description
Manufacturer	:	CCEWOOL
Reference	:	Ecological fiber blanket
Material	:	Ceramic Fiber – composed majorly of silica and calcium oxide
Density	:	128 kg/m ³
Location	:	Around the vertical edges and head of the specimen – See Figure 26
Overall size	:	
<ul style="list-style-type: none"> • Length 	:	Cut into sections around the perimeter of the specimen
<ul style="list-style-type: none"> • Width 	:	150 mm
<ul style="list-style-type: none"> • Thickness 	:	25 mm

Instrumentation and equipment	The instrumentation was provided in accordance with BS EN 1365-1:2012 Corr. 2013 and BS EN 1363-1:2020.	
Pre-test conditioning	The test specimen was subjected to normal laboratory temperatures and conditions between the completion of construction of the test specimen and the start of the test.	
Installation details	The specimen was received pre-assembled and delivered during January 2024. The specimen was installed directly into a refractory line steel restraint frame, fitted centrally to a steel spreader beam by representatives of Warringtonfire with assistance from representatives of the sponsor. The gaps between the specimen and the restraint frame were filled with mineral wool, nominal density 33kg/m ³ , to prevent flames coming around the edge of the specimen and also to allow free movement of the wall specimen. There was additional fire stopping on the exposed face as stated in the technical specification (Item 9) and Figure 26

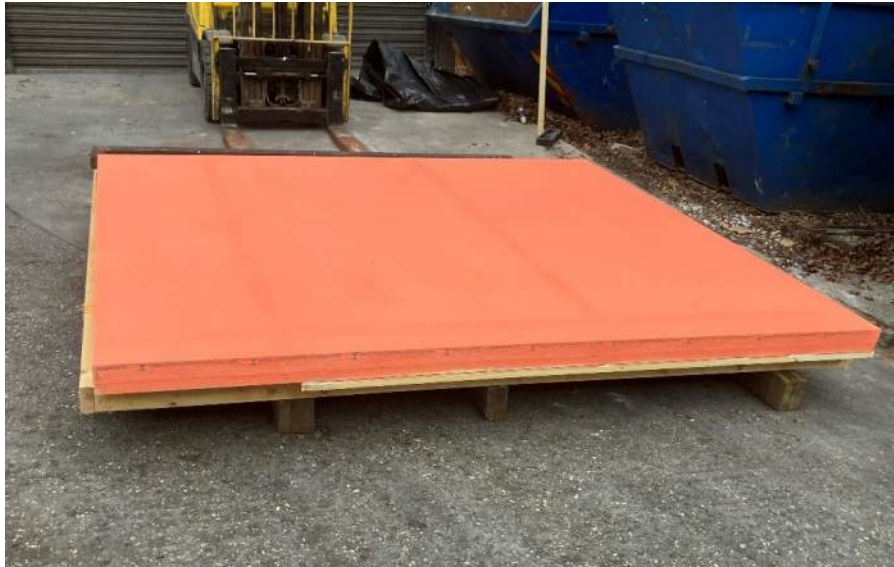
Figure 27 Photo showing fleece tape applied to external edges of the specimen

7. Jointing tape (2)		Description
Manufacturer	:	Intelligent Membranes
Reference	:	100 mm Fleece tape*
Material	:	Polymer film
Location	:	Centrally to the perimeter of the specimen as shown in Figure 27
