Certificate Of Analysis

Date : 28-05-2021
Subject : Testing INTELLIGENT PROTECT
Your Code : **INTELLIGENT PROTECT**
Laboratory Number : 204624Ba
Sampling : By the client
Period of Investigation : 14-12-2020 until 04-02-2021

The client has asked SGS INTRON to assess whether the sprayed temporary protection film has sufficient resistance against sparks of grinding metals and of welding metal.

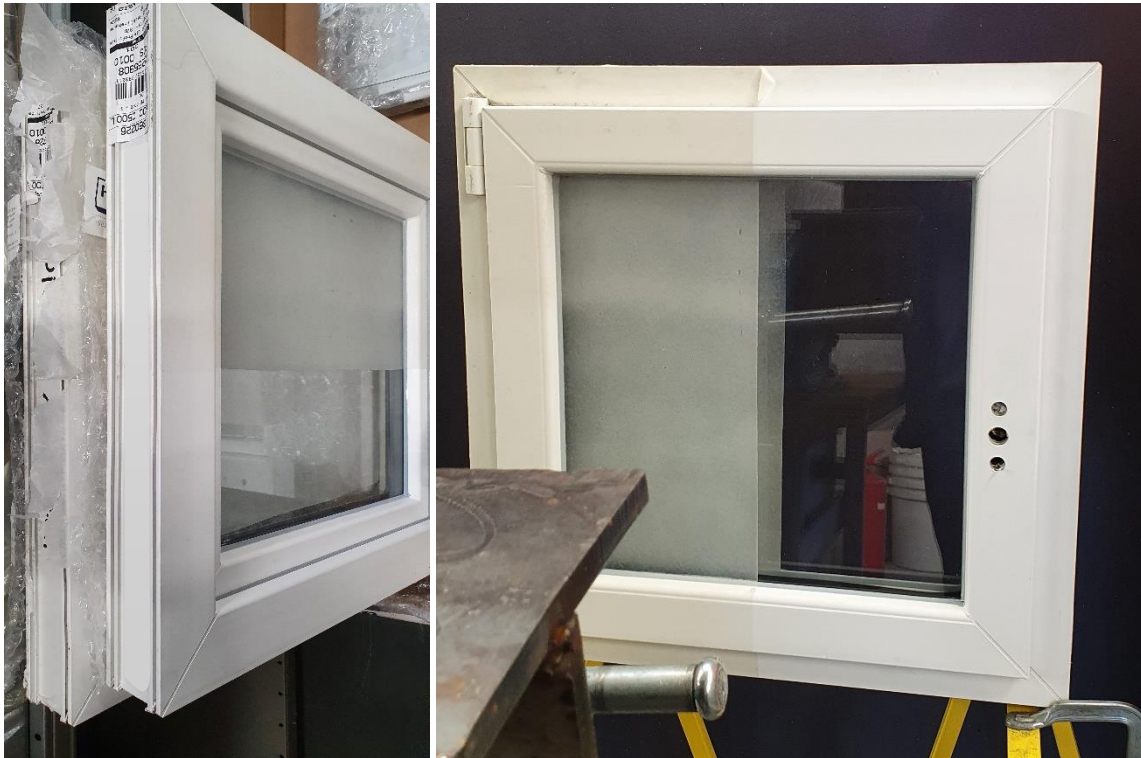
Photo - the received sample from the client. The temporary protective film is cream white

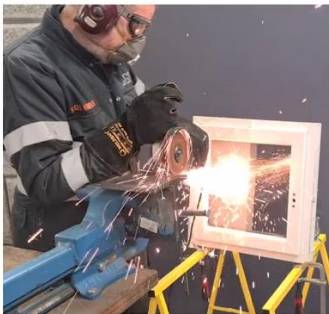
carbon steel

All tests are performed for 30 seconds at a distance of 50 cm on the same window frame.

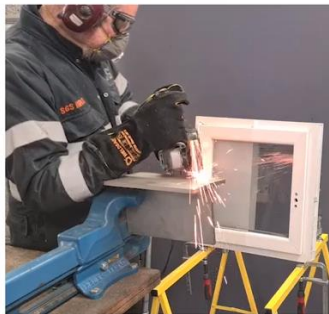
stainless steel

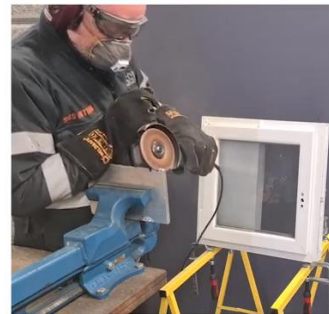
aluminum

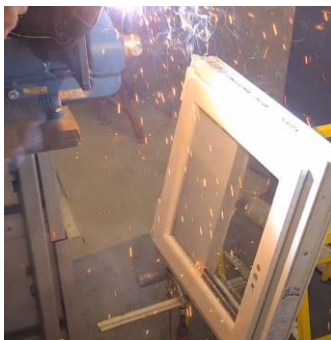
metal welding
